**AmeriSpec Inspection Services**  
**Inspection Report**  
(604) 430 – 0343

**This home is a condominium in a multiple story wood frame building.**

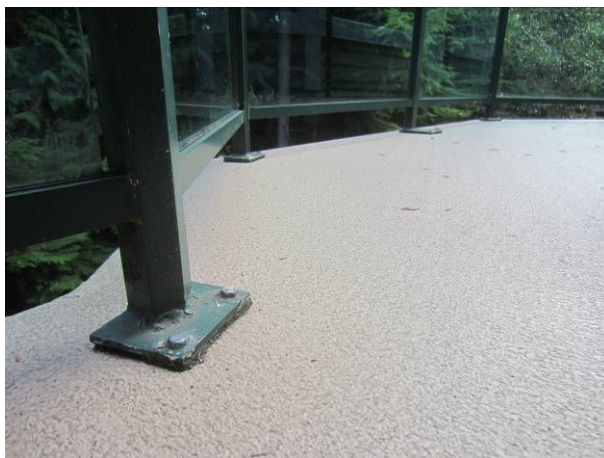
N.  
Serviceable. No GFI provided to outlet. See #408.  
Waterproof membrane over wood structure.  
N.  
Metal & Glass. Recommend sealing around railing penetrations into balcony to prevent possible moisture ingress. Recommend reviewing with strata representatives or Management Company.  
Limited access to underside for inspection.

Recommend sealing around balcony railing penetrations.

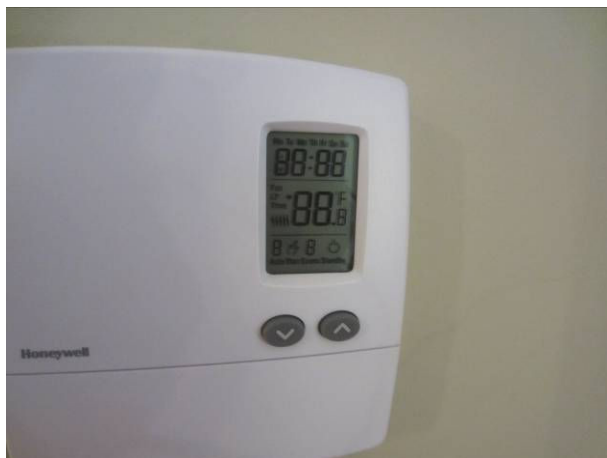
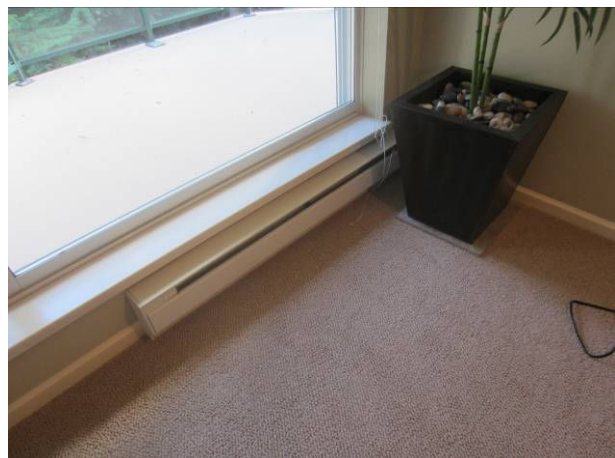
- 401 Heating:** Electric baseboard.
- 403 Thermostats: Thermostat in living room was not working adequately at time of inspection. Error signs were showing on display. Indicating problem with thermostat or electric baseboard. Recommend a review by a qualified contractor. Repair or replace as required.

Error signs on thermostat display. Electric baseboard is not working adequately.

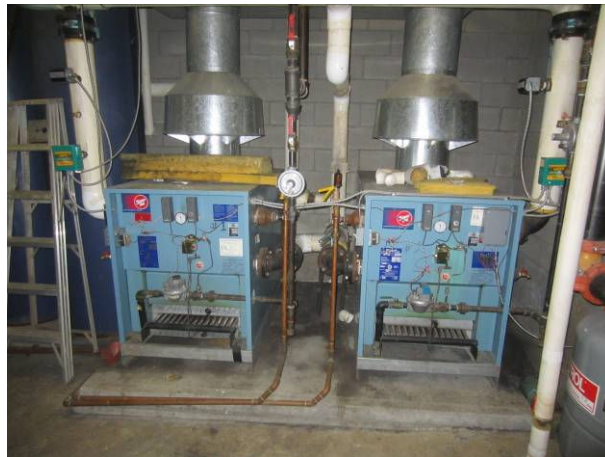
Hot water is provided by a central boiler system, located in underground parking level. Hot water noted at all fixtures inside unit. Boilers are original to complex and are in serviceable condition. Due to the complex and inaccessible nature of these systems, client is advised to consult a qualified heating contractor for verification of performance. Recommend reviewing with strata representatives or Management Company.

Hot water boilers.

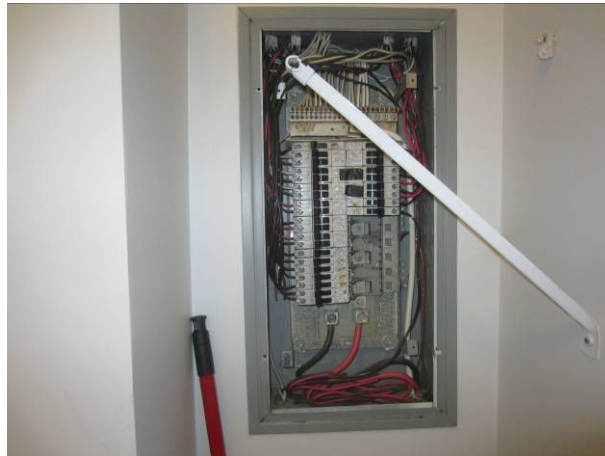
Electrical panel.

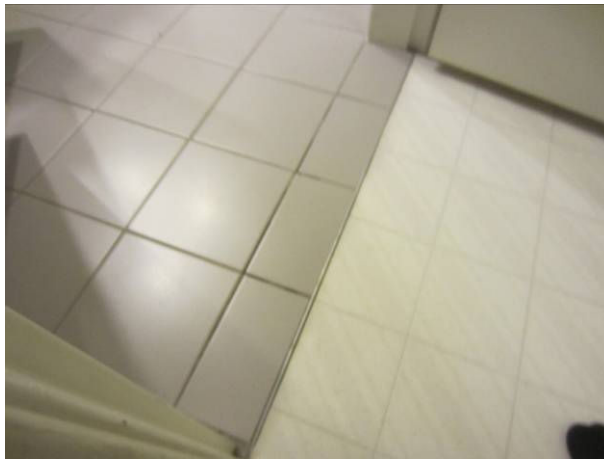
701 Floor:	Tile cracked grout noted in areas. Repair or replace as required.
------------	---

Cracked grout noted to bathroom floor tiles.

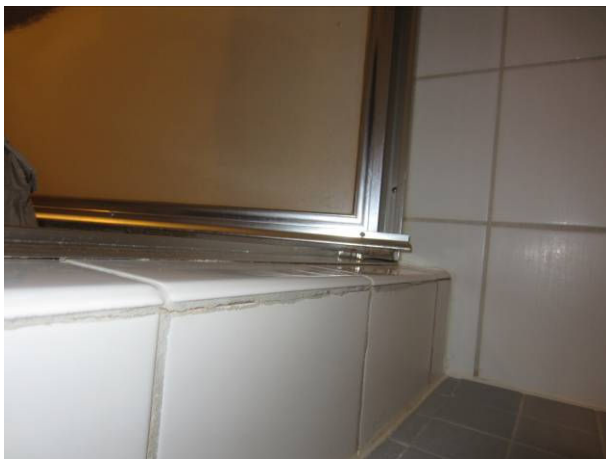
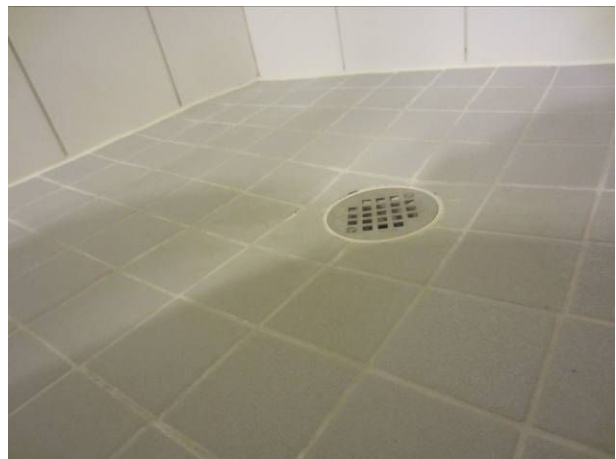
Cracked grout noted inside shower stall.

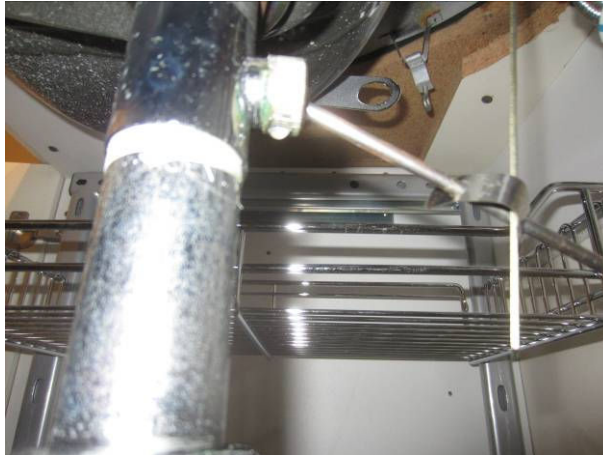
- 713 Shower Door: Glass.
- 714 Shower Head: Serviceable.
- 715 Sink: Serviceable.
- 716 Sink Faucet: Serviceable.
- 717 Drain/Supply Pipes: Small drip leak noted from stopper arm. Repair or replace as required.

Drip leak noted at stopper mechanism under sink.
