**AmeriSpec Inspection Services**  
**Inspection Report**  
(604) 430 – 0343

**This home is a condominium in a multiple story wood frame building.**

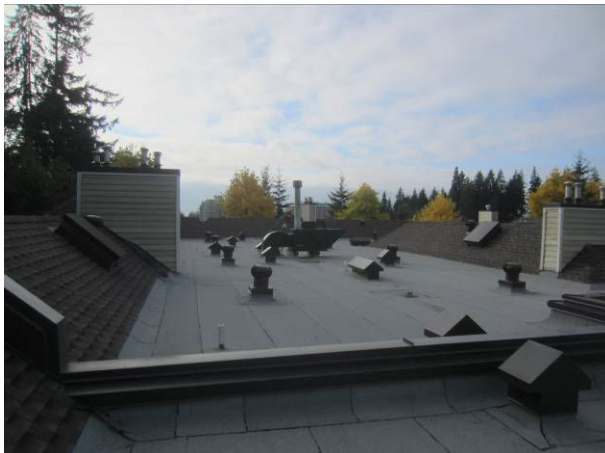
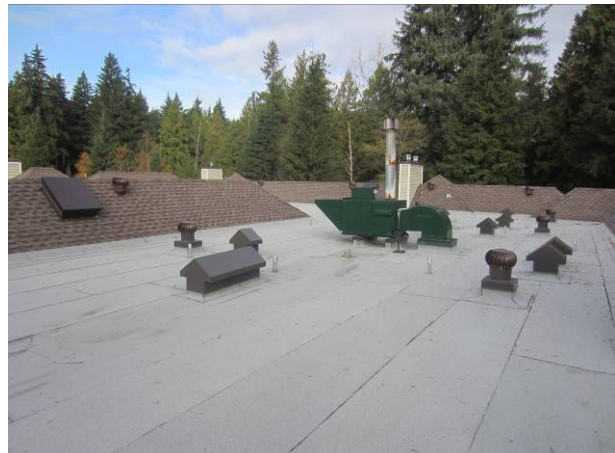
- 126 Comments: Review is in relation to building #3690 of this complex only. Recommend reviewing with strata representatives or Management Company.
